CONDITION ASSESSMENT AND EVALUATION OF THE NARAHENPITA RAILWAY BRIDGE

U.Wickramaratna, R.Wijedasa, J. Liyanagama, L.S.S. Wijewardana and P.A.K. Karunananda

Department of Civil Engineering, Open University of Sri Lanka

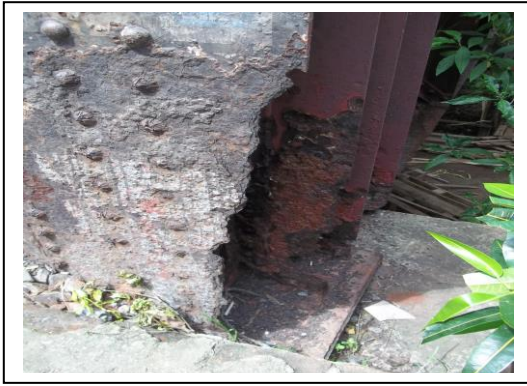
Physical inspection revealed that the end box of the plate girder is highly corroded and deteriorated at the Kirulapone end approach due to a high-level of corrosion. Further, the bottom chord of the girder and the steel troughs are also corroded. All the weep holes are blocked and visible sedimentation is also present. In addition, the box girder in the Narahenpita end approach is also heavily corroded. The present condition is not favorable to carry the loads of heavy engines like “M class” locomotives. Figure 2 shows the current state of the end box at the Kirulapone end.

Figure 2: View of the corroded end box

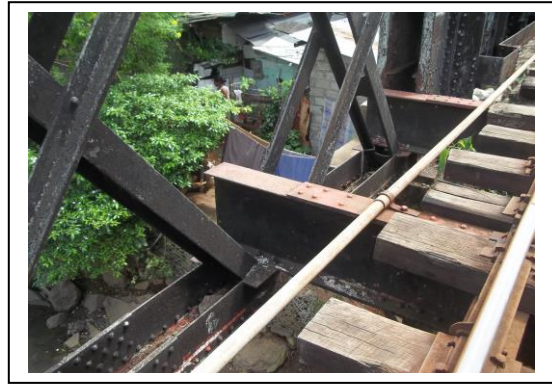
Figure 3: View of the cross girder-bottom girder connection

The truss girder bridge is 32.0 m long Double Warren open deck type semi through bridge. At the time of conversion from narrow gauge to broad gauge, the bridge deck and top chord were strengthened to suit for the S-class loading (14.5 Tons axle load) and to maintain an average speed less than 40 km/hr. As per the visual inspection end box of Narahenpita end approach is heavily corroded and decayed. The provision of the additional stinger beam to cross girders at the strengthening stage has caused additional vibration effects to the bridge. The view of the cross girder-bottom chord connection is shown in Figure 3.

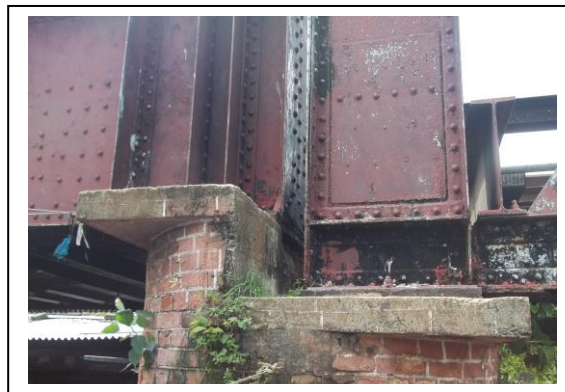
The centre pier of the present bridge, constructed of brick masonry has distinctive cracks at the top which appear to spread towards the bottom of the pier. Therefore, it is difficult to make a proper judgment on its load carrying capacity since structural details of the bridge pier are not available with SLR. Due to the change of the stream flow path, there is an extensive scouring damage at the Narahenpita end abutment. Soaking of the abutments at the high floods may further damage the brick pier and abutment. This effect has been worsened due to the construction of a gabion wall in the river bank recently. The gabion wall has reduced the width of the water way from 50m to 30m.

Figure 4: View of the centre pier
