THE PARTIAL REPLACEMENT OF COARSE AGGREGATES BY CRUSHED ROOF CLAY TILES/CLAY BRICKS IN THE INTERLOCKING PAVING BLOCK PRODUCTION

Yasir M.R.^{1}, Gunathilake A.M.L.N.¹*

¹Department of Civil Engineering, The Open University of Sri Lanka

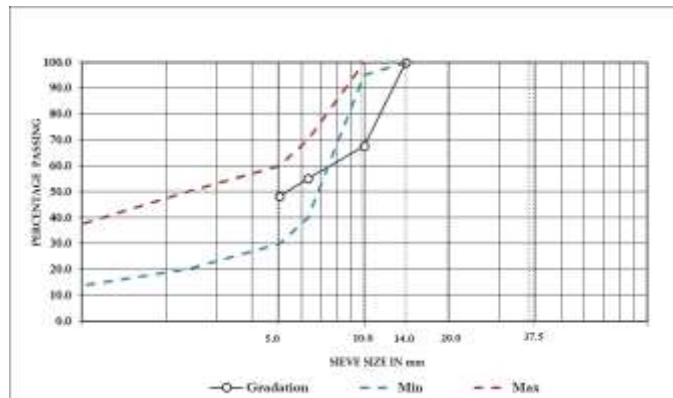
Figure 1: Particle size distribution of crushed brick waste

It was decided to consider strength class 3 (as per SLS 1425: part 1) to study the possibility of the partial replacement of coarse aggregates, in interlocking blocks, with broken clay brick particles and broken roof clay tile particles separately. The partial replacement percentages of 20%, 40%, and 60% were selected for this, considering the results of previous studies on concrete (Akshay et al, 2022, Apebo et al, 2013, Priyanka et al, 2019). The maximum particle size coarse aggregates in all cases were maintained at 10mm considering local industrial practices and the recommendations of IS 15658:2006, which is the Indian standard for interlocking paving block production. The potential coarse aggregates produced of broken clay brick particles and broken roof clay tile particles were checked against the limits specified in BS 812 through sieve analyses. The results of these sieve analyses are presented in Figures 1 and 2 in relation to broken clay brick particles and broken roof clay tile particles, respectively. According to the results, it is clear that maintaining the particle distribution of broken brick tiles within specified limits is not exactly possible due to the breakage of bricks during crushing. However, particle distribution could be maintained very close to the specified limits with broken roof clay tiles.

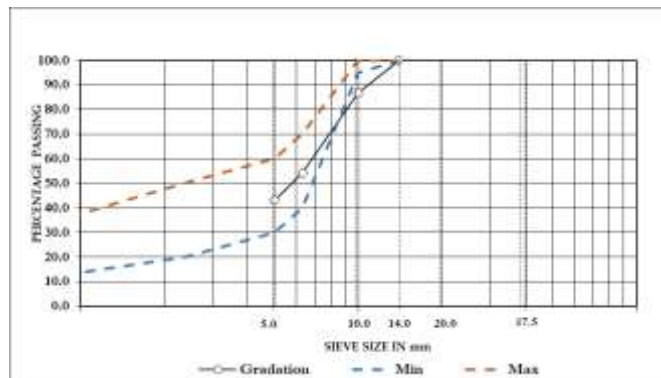
Figure 2: Particle size distribution of crushed roof clay tile waste

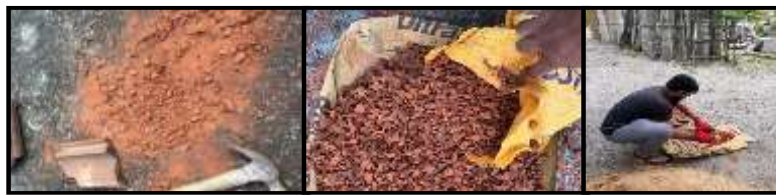
Figure 4 : Photographs of the alternative coarse aggregates produced

Photographs of the alternative coarse aggregates produced and those taken during the production of samples are presented in Figures 4 and 5, respectively.

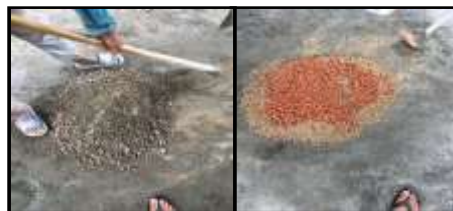
Figure 5: Photographs taken during the production of samples

Accordingly, sample interlocking blocks were cast with partial replacement percentages of 20%, 40%, and 60% of coarse aggregates with broken brick and broken roof clay tile particles separately. The curing of samples was done by immersing them in water after the initial setting time. The 220mm x 110mm x 80mm (Length x Width x Thickness) standard size Non-Rectangular shape moulds (complying with SLS 1425- Part I: 2011) were used for the production of samples, as it was one of the most common shapes used in the industry. The typical shape of the block is shown in Figure 3.

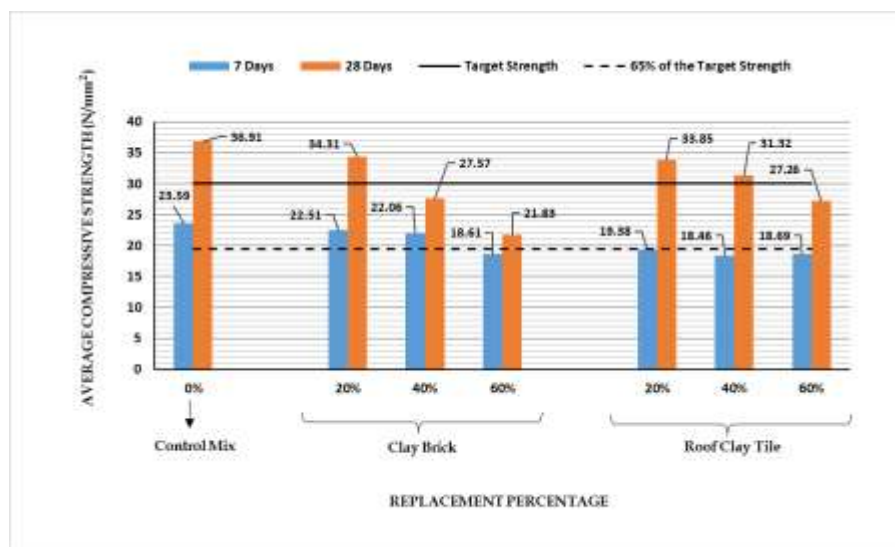
A standard compressive strength test of samples was carried out as per the standard procedure of SLS 1425: part 2. The average compressive strength results at 7 days and 28 days are presented in Figure 6.

Figure 6: Average compressive strength results at 7 days and 28 days

According to the results, the highest average compressive strength was reported in the control samples at both 7 days and 28 days. In the case of samples where the partial replacement of coarse aggregates was done using broken brick or roof clay tile particles, the target 28 days compressive strength was achieved only in the samples that had the partial replacement of coarse aggregates of 20% of broken clay brick particles, 20% of roof clay tile particles, and 40% of broken roof clay tile particles.

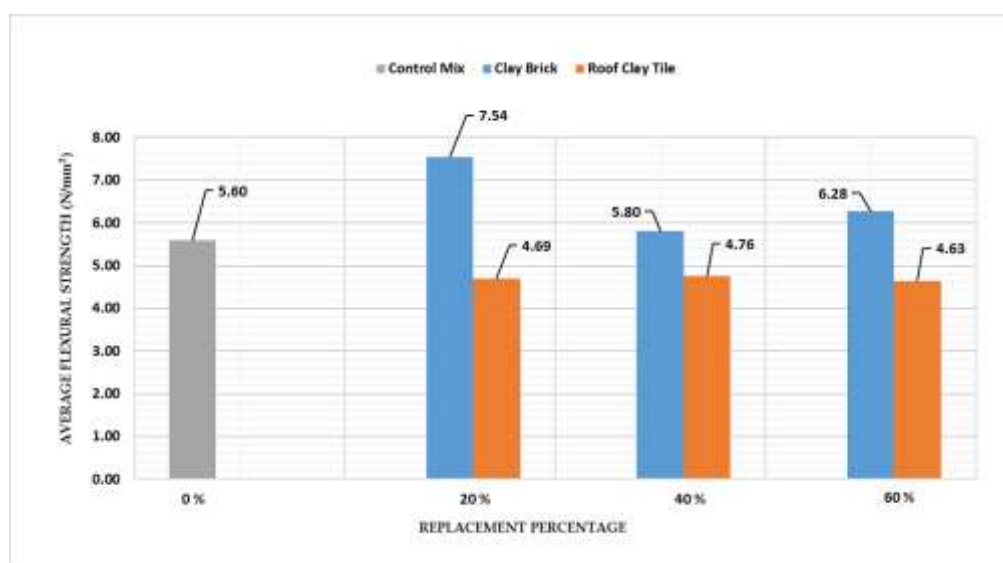
Figure 7: Average Flexural strength of samples

Even though SLS 1425 does not specify the requirement of flexural strength, a flexural strength test was also performed as per the Indian standard (IS 15658:2006) as SLS 1425 also indicate specifying the flexural and tensile tests in its future revisions. The average 28 days flexural strength of the considered samples are presented in Figure 7. As per the results, the highest average flexural strength was reported in samples that had 20% partial replacement of coarse aggregates with broken clay bricks. All other samples using broken clay bricks also showed a higher average strength than the average flexural strength of control samples. However, all samples using broken roof clay tile particles showed a lesser average flexural strength than the average flexural strength of the control samples. The availability of a higher percentage of fine particles with the broken clay bricks would be a probable reason for this observation (the percentage of material passing the 5mm sieve size in broken clay bricks is close to 50% and while it is only about 40% with broken clay tiles; refer Figures 1 and 2). However, the flexural strengths shown by all the samples have satisfied the criteria specified for the heavy duty/industrial roads as per the Indian standard.
